# Manhole Inspection Summary

Manhole # S09WW\_004MH

Insp Date: **1/27/09 10:46 AM**

**Location** Address: **3500 EDGEWOOD RD**

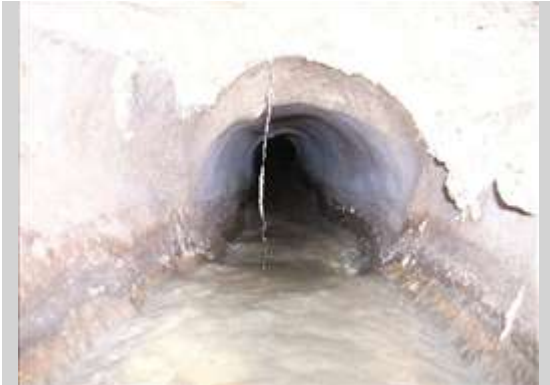
12 O'Clock Outflow

8 in. Circular Gravity Sewer  
Pipe Out @ 12 O'Clock

Pipe Height: (in.) Direct  
Pipe Material: **PVC** ☐ Pipe Lined  
Invert Depth: **6.60** (ft.) Flow Characteristics: **Slow**  
Deposits: ☒ None ☐ Mud ☐ Sludge ☐ Debris ☐ Grease  
Silt Depth: (in.) Deposits Extent:  
Infiltration: **None** Pipe Seal Cond: **Sound**

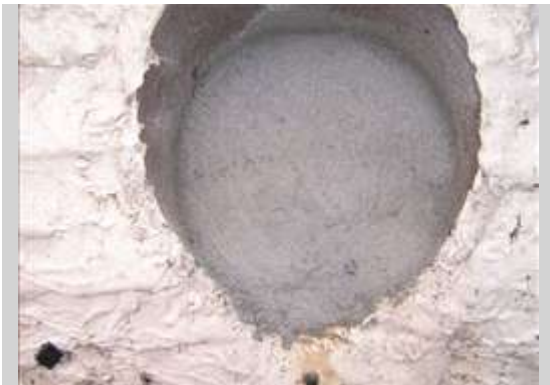
4 O'Clock Inflow

15 in. Circular Gravity Sewer  
Pipe In @ 4 O'Clock

Pipe Height: (in.) Direct  
Pipe Material: **Unknown** ☐ Pipe Lined  
Invert Depth: **4.42** (ft.) Flow Characteristics: **None**  
Deposits: ☒ None ☐ Mud ☐ Sludge ☐ Debris ☐ Grease  
Silt Depth: (in.) Deposits Extent:  
Infiltration: **None** Pipe Seal Cond: **Sound**

Connects To: **Dead End**

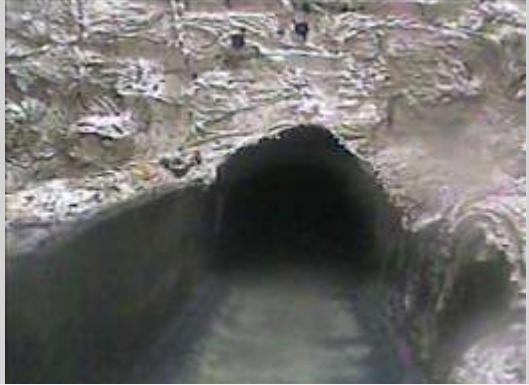
6 O'Clock Inflow

8 in. Circular Gravity Sewer

Pipe In @ 6 O'Clock

Pipe Material: **PVC** ☐ Pipe Lined

Infiltration: **None** Pipe Seal Cond: **Sound**
